**A PARCEL PROPERTY LAND AND
TWO-STORY BUILT ON DWELLING,
SITUATED AT BUENA VISTA 9**

“DRIVE BY” APPRAISAL REPORT 2024_413

SEPTEMBER 3, 2024

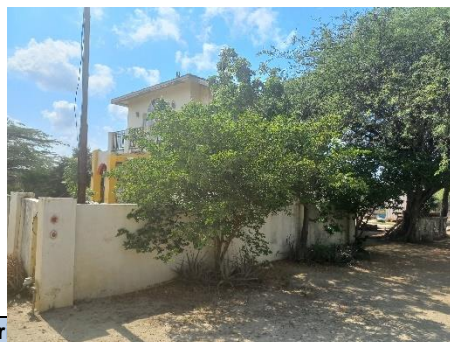
- The premises were inspected only on the outside
- Show several visible defects and the overall condition of maintenance, limited to the exterior, is moderate
- The premises appears to be unoccupied

- *The dwelling overall requires maintenance*
- Based on the maintenance condition on the outside, a similar condition is assumed for the inside

MAINTENANCE TABLE	N	G	S	M	I	P	U	Clar
Foundation			X					
Floors			X		X			Degraded balcony floor
Walls			X		X			Degraded wall (second floor)
Roof			X	X				Several areas roof show sign of water leakage (roof inspection recommended!) Damaged multiplex boarding / rotten face board Broken ceramic roof tile
Frames, windows and doors				X				Damaged wooden door
Floor and wall tiles								N/A
Ceiling								N/A
Painting					X			Exterior walls, wooden frames/doors and fence wall
Kitchen								N/A
Bathroom fixtures								N/A
Plumbing								N/A
Electrical installation								N/A
Hardscape and/or landscaping			X					
Fencing					X	X		Corroded metal fencing Degraded walls Several areas of fence walls require replaster
