**FOUR PARCELS PROPERTY LAND
AND TWO-STORY BUILT ON
DWELLING, SITUATED AT ZUSTER
CHERUBINESTRAAT 6**

APPRAISAL REPORT 2024_412

SEPTEMBER 3, 2024

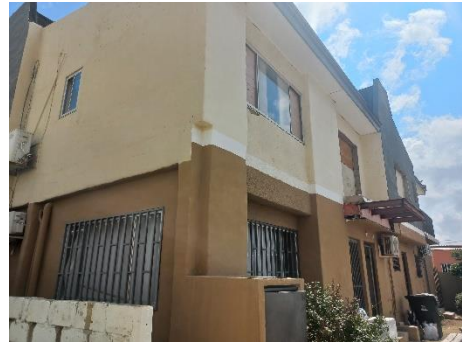
- The premises were inspected only on the outside
- Show several visible defects and the overall condition of maintenance, limited to the exterior, is sufficient to moderate
- The apartments appear to be occupied

- *Dwelling has only been inspected from the outside*
- *Based on the maintenance condition on the outside, a similar condition is assumed for the inside*
- *It appears that the building is under renovation/construction*

MAINTENANCE TABLE	N	G	S	M	I	P	U	Clarification
Foundation			X					
Floors			X					
Walls			X					
Roof			X					
Frames, windows and doors			X		X		X	Exterior door damaged Several windows are missing
Floor and wall tiles								N/A
Ceiling								N/A
Painting			X	X				Exterior walls and fence wall require repainting
Kitchen								N/A
Bathroom fixtures								N/A
Plumbing			X					
Electrical installation			X					
Hardscape and/or landscaping			X	X				Concrete floor cracked
Fencing								N/A
<p><i>N: new (within 1 year after completion)</i> <i>G: good = as new</i> <i>S: sufficient = no maintenance excepted within 2 years</i> <i>M: moderate = maintenance excepted within 2 years (clarification)</i> <i>I: insufficient = maintenance / repair necessary (clarification)</i> <i>P: poor = replacement necessary (clarification)</i> <i>U: unfinished</i></p>
