**FOUR PARCELS PROPERTY LAND
AND TWO-STORY BUILT ON
DWELLING, SITUATED AT ZUSTER
CHERUBINESTRAAT 6**

APPRAISAL REPORT 2024_412

SEPTEMBER 3, 2024

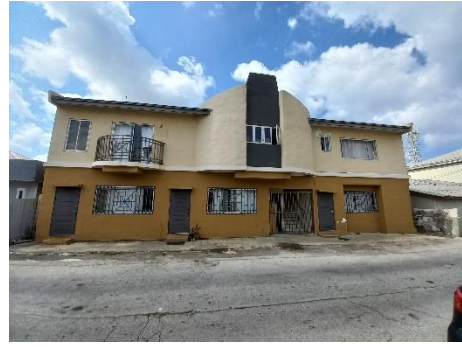
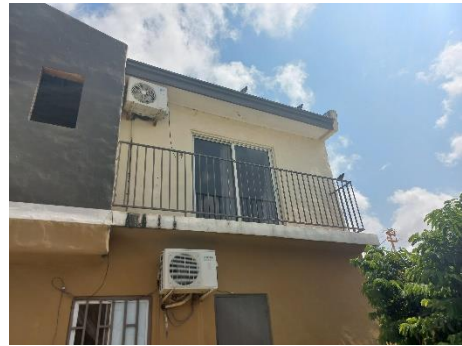
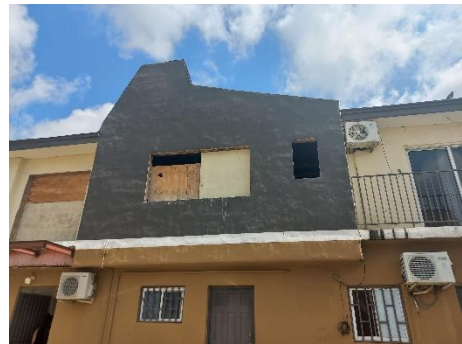
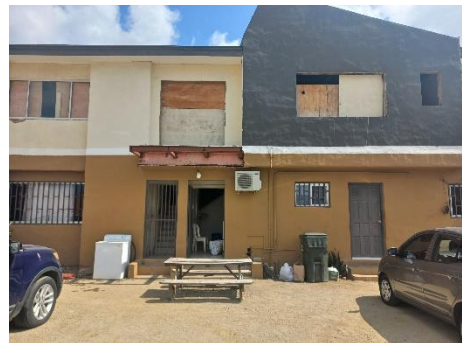
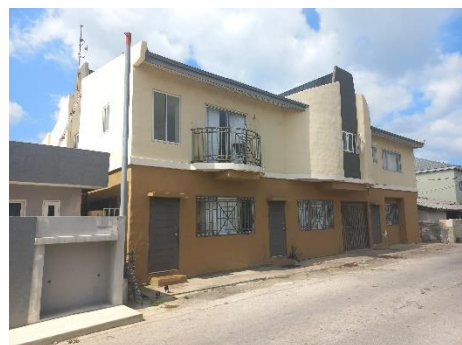
- The premises were inspected only on the outside
- Show several visible defects and the overall condition of maintenance, limited to the exterior, is sufficient to moderate
- The apartments appear to be occupied

- *Dwelling has only been inspected from the outside*
- *Based on the maintenance condition on the outside, a similar condition is assumed for the inside*
- *It appears that the building is under renovation/construction*

MAINTENANCE TABLE	N	G	S	M	I	P	U	Clarification
Foundation			X					
Floors			X					
Walls			X					
Roof			X					
Frames, windows and doors			X		X		X	Exterior door damaged Several windows are missing
Floor and wall tiles								N/A
Ceiling								N/A
Painting			X	X				Exterior walls and fence wall require repainting
Kitchen								N/A
Bathroom fixtures								N/A
Plumbing			X					
Electrical installation			X					
Hardscape and/or landscaping			X	X				Concrete floor cracked
Fencing								N/A
<p><i>N: new (within 1 year after completion)</i> <i>G: good = as new</i> <i>S: sufficient = no maintenance excepted within 2 years</i> <i>M: moderate = maintenance excepted within 2 years (clarification)</i> <i>I: insufficient = maintenance / repair necessary (clarification)</i> <i>P: poor = replacement necessary (clarification)</i> <i>U: unfinished</i></p>
